**Flood Control Project Maintenance
Levee Inspections**
LMA District Cover Sheet
Spring 2019 Levee Inspection Results

Reclamation District No. 1601 Twitchell

Spring 2019 Levee Inspection Results

| Waterway | | | Bank | Unit Miles |
|--|---|---|---|---|
| Unit No. 01 Threemile Slough | | | Left | 2.43 |

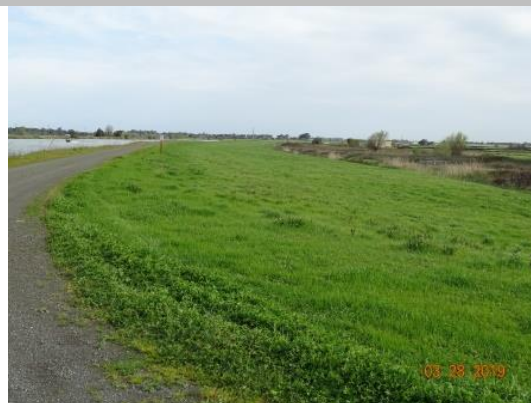
Photo 1 of 1 : SP_2019_RD1601_237_9_20190329_00013.jpg

| LMA doing a good job maintaining annual vegetation | | | | | |

View looking upstream at annual vegetation on the landside slope (Spring 2019).

| V1 : Control annual grass and weeds on the levee slopes and easements. | | | | | |

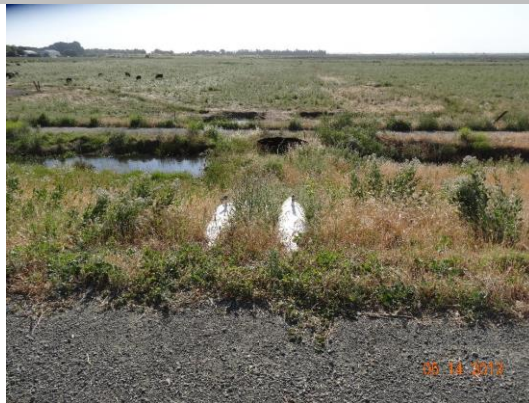
Photo 2 of 3 : UCIP_SP_2019_22043_37622.jpg

| FS_ID:22043 DS_ID:20950 EP_NO: 11227 Repair Type: Non-Urgent Crossing Status: Found UCIP Comments: Appears this crossing might be been recently modified--exposed section of pipe is protected with white paint. Need to contact owner to obtain records. Recommend clearing vegetation along the pipe alignment. FIELD_STRUCT_DESC: 12-inch pipe (not 12-inch pipe as original description noted) through the levee, 4 feet below the crown. Siphon primer on waterside (WS) shoulder. 36-inch steel (not concrete as original description noted) pipe with shut-off valve inside at landside (LS) toe ditch. (12-inch pipe authorized under Automatic Board Order (ABO) issued as Permit No. 11227, 1975-Standard Oil of California; no permit found for 14-inch pipe) [Additional Reference(s): DWR Levee Logs, 2005] FS Date: 5/14/2013 | | | | | | |

View of landward side with canal located at toe.

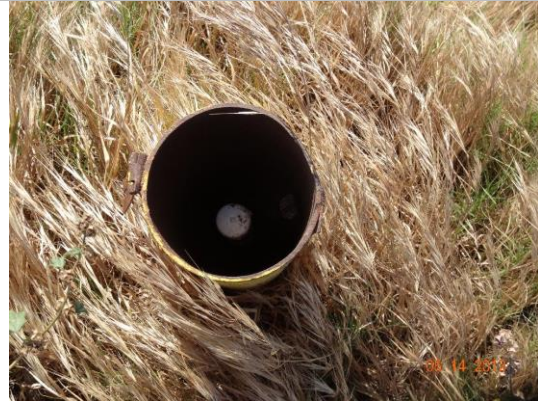
Photo 3 of 3 : UCIP_SP_2019_52959_71861.jpg

| FS_ID:52959 DS_ID:24069 EP_NO: N/A Repair Type: Non-Urgent Crossing Status: Indicator Found UCIP Comments: 03/08/2018 No supporting documentation was received for this crossing by KSN Inc. to determine the fate of this encroachment. Need to contact KSN Inc. (Dcarr@KSNinc.com) to obtain documentation for the removal or abandonment of encroachment. (O. Magana - DWR UCIP) 03/19/2009 Unable to determine if line crosses levee. Need to contact owner to determine if crossing goes through levee. Also need to determine permit authorizing work on landward side. (O. Magana - DWR UCIP) FIELD_STRUCT_DESC: Steel stand pipe with PVC pipe inside located on landside (LS) shoulder. Rip rap located on waterside (WS) slope. Unable to determine if crossing goes through levee. Appears to be monitoring gas well. FS Date: 3/19/2009 | | | | | | |

PVC pipe inside standpipe located on landward side.

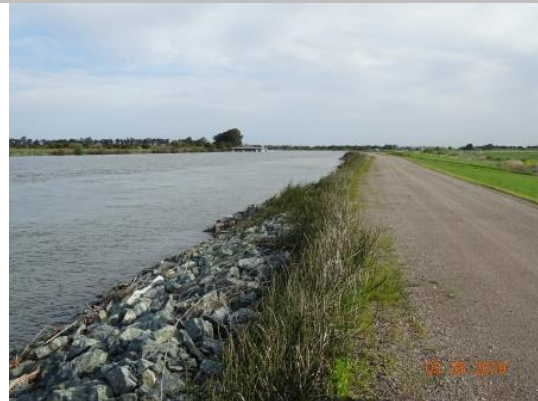
Photo 1 of 1 : SP_2019_RD1601_237_11_20190329_00015.jpg

View looking upstream at horsetail vegetation on the waterside shoulder (Spring 2019).

| V1 : Control annual grass and weeds on the levee slopes and easements. | | | | | |

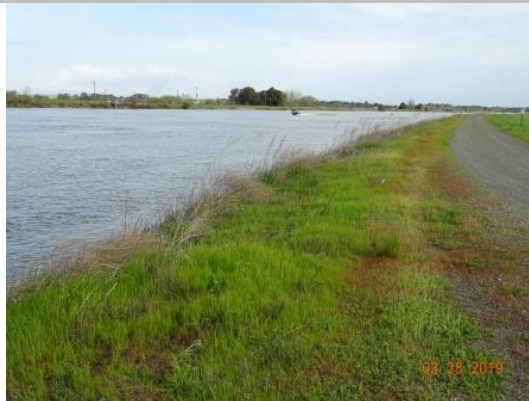
Photo 1 of 1 : SP_2019_RD1601_237_10_20190329_00014.jpg

| LMA doing a good job maintaining annual vegetation. | | | | | |

View looking upstream at the annual vegetation on the waterside slope (Spring 2019).

| V1 : Control annual grass and weeds on the levee slopes and easements. | | | | | |

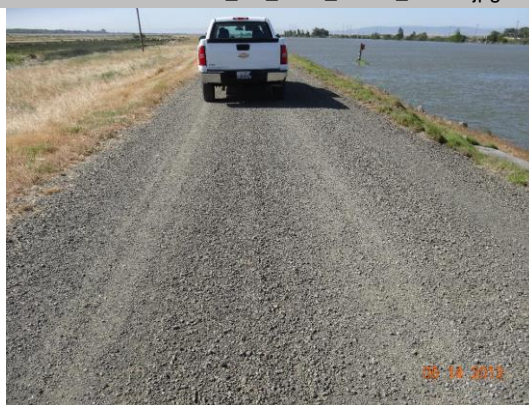
Photo 1 of 3 : UCIP_SP_2019_19545_33173.jpg

| FS_ID:19545 DS_ID:20951 EP_NO: 2909A Repair Type: Non-Urgent Crossing Status: Found UCIP Comments: Appears this crossing might be been recently modified--exposed section of pipe is protected with white paint. Need to contact owner to obtain records. Recommend clearing vegetation along the pipe alignment. Dense vegetation on landward slope limits the inspector's visibility to identify signs of leaks along levee slope. FIELD_STRUCT_DESC: 8-inch siphon irrigation pipe through levee, 2.4 feet below crown. Cutoff wall around pipe at center of levee. Siphon breaker on apex of pipe on landside (LS) shoulder. Hand primer pump on LS slope. (8-inch pipe authorized under Permit No. 2909A, 1960-J. Souza). [Additional Reference(s): DWR Levee Logs, 2005] FS Date: 5/14/2013 | | | | | | |

View of levee crown looking downstream at crossing.

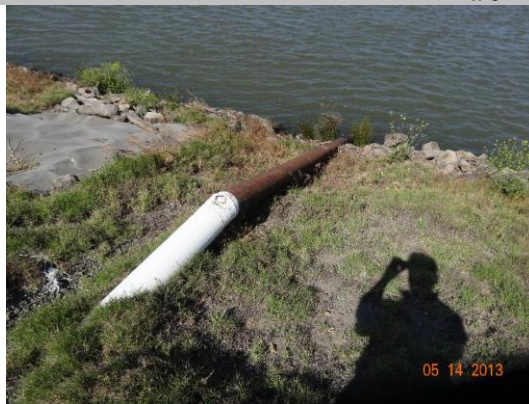
Photo 3 of 3 : UCIP_SP_2019_19545_33171.jpg

| FS_ID:19545 DS_ID:20951 EP_NO: 2909A Repair Type: Non-Urgent Crossing Status: Found UCIP Comments: Appears this crossing might be been recently modified--exposed section of pipe is protected with white paint. Need to contact owner to obtain records. Recommend clearing vegetation along the pipe alignment. Dense vegetation on landward slope limits the inspector's visibility to identify signs of leaks along levee slope. FIELD_STRUCT_DESC: 8-inch siphon irrigation pipe through levee, 2.4 feet below crown. Cutoff wall around pipe at center of levee. Siphon breaker on apex of pipe on landside (LS) shoulder. Hand primer pump on LS slope. (8-inch pipe authorized under Permit No. 2909A, 1960-J. Souza). [Additional Reference(s): DWR Levee Logs, 2005] FS Date: 5/14/2013 | | | | | | |

View of crossing on waterward slope. Rip rap present at waterward toe.
